INSTRUCTIONS FOR THUMB RELEASE REPLACEMENT:

MODELS:

750P 760P 770P 780P 785P SL675P

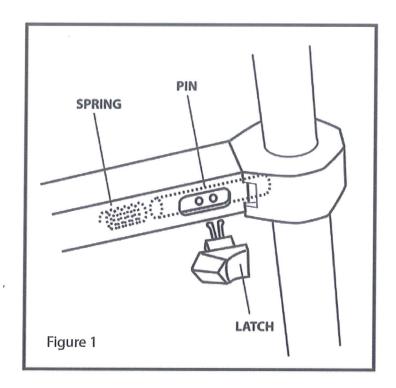
- 1. Examine the Ladder to make sure that there is no additional damage to the ladder.
- 2. Inspect the "key hole" that the thumb release came out of to determine if the thumb release can be repaired or not.
 - a. If the "locking pin is still in place, the thumb release can be re secured. (Figure 2)
 - b. If you do not see the "locking pin" or you see a steel spring in the place where the "locking pin" should be, the ladder cannot be serviced. DO NOT take the ladder apart. (Figure 3)
- 3. Align the barbed prongs with the 2 holes in the "locking pin." (Figure 1)
- 4. Press the latch barbs through the "locking pin" with firm pressure.
- 5. Test the section of the ladder by opening and closing the section a few times to insure proper operation.
- 6. Inspect the ladder a last time to make sure there is not any other operational issues.
