### MFJ-P2T, MFJ-P3T, MFJ-PL2T

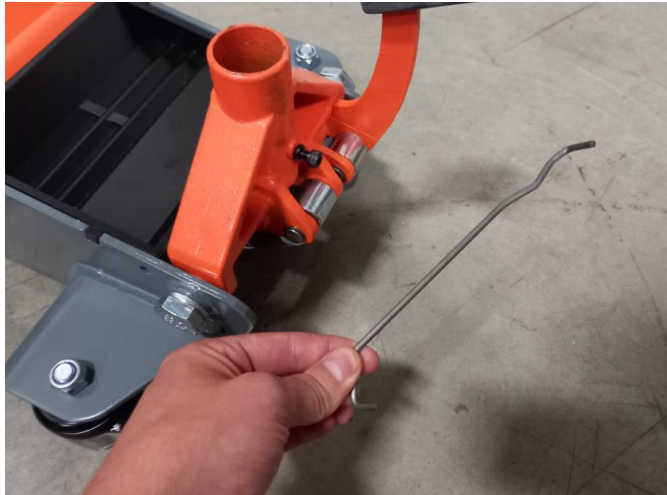
1. Make sure that the retaining device has been removed from the arm base.

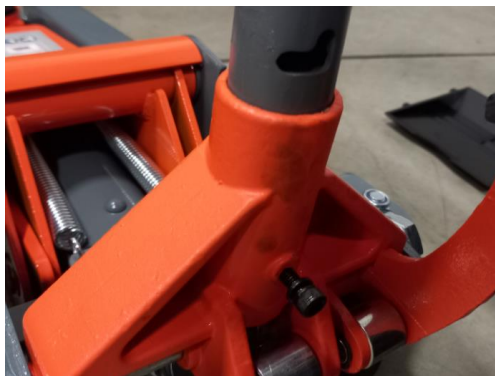
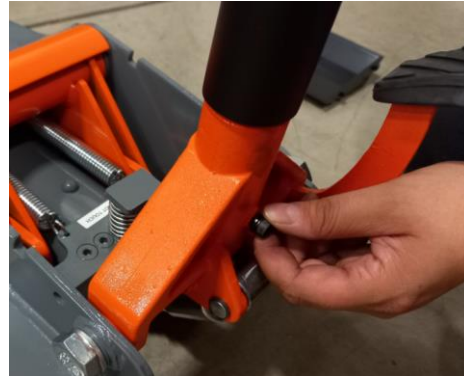
2. Check that the handle is correctly positioned inside the base. It should be secured with the provided fastener.

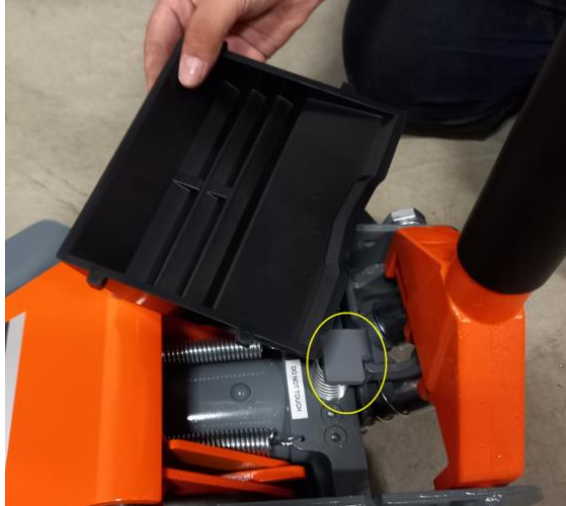
3. If you have problems with lifting, remove the panel cover and make sure the pressure relief valve is not stuck. While turning the T handle, the valve mechanism should turn and return to position freely.

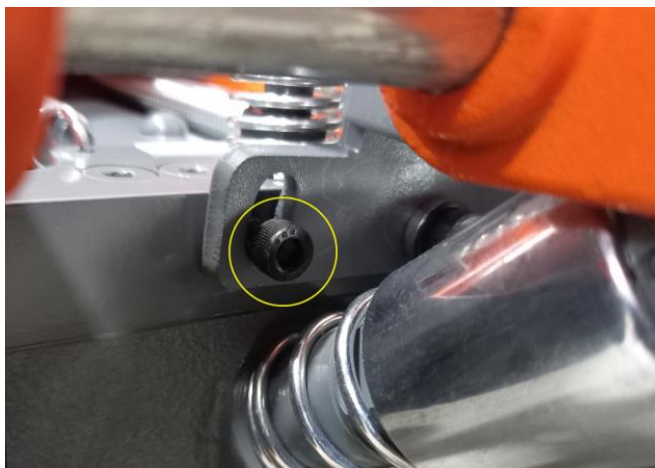
If the valve mechanism does not return freely, slightly unscrew the guiding screw.
